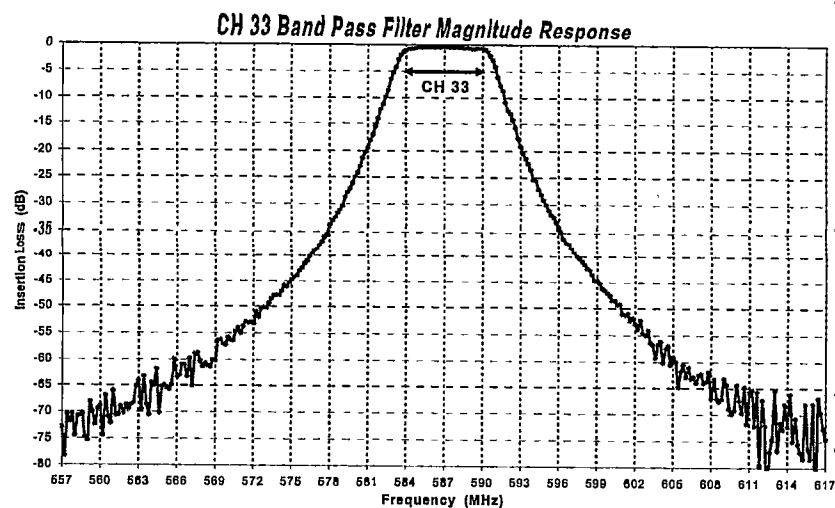
**Figure 6a CH 33 (587 MHz) bandpass filter magnitude response**

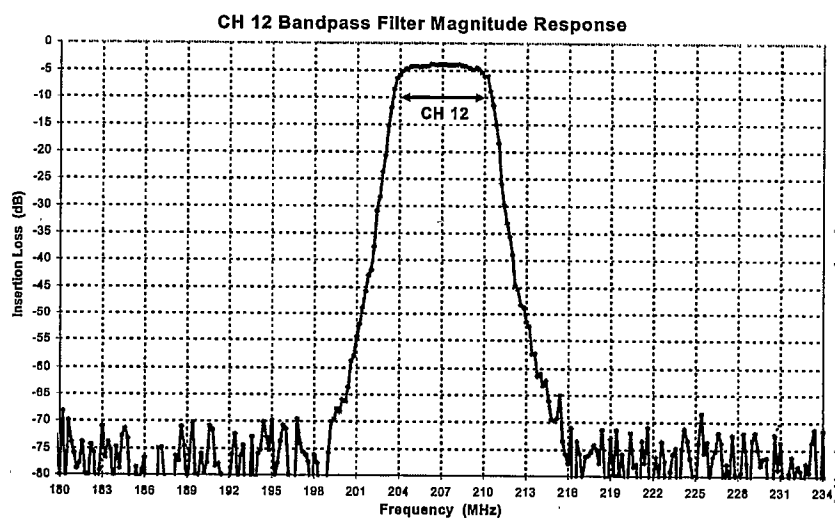
**Figure 6b CH 12 (207 MHz) bandpass filter magnitude response**

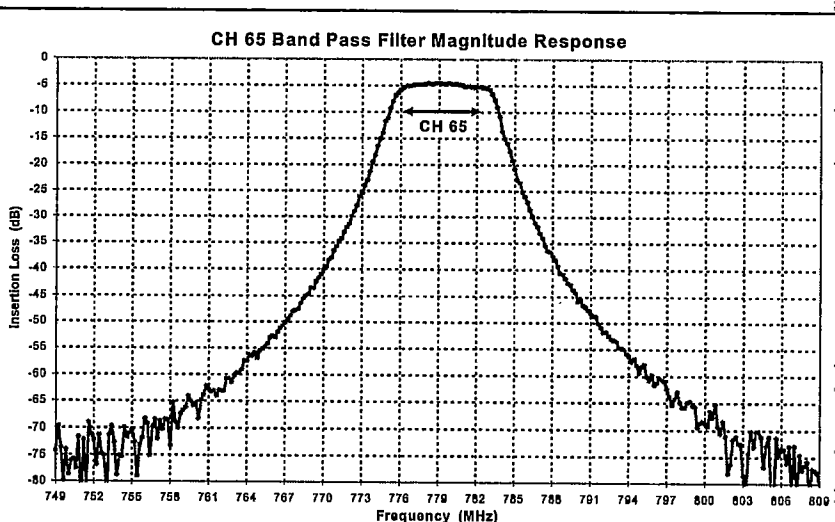
**Figure 6c CH 65 (779 MHz) bandpass filter magnitude response**

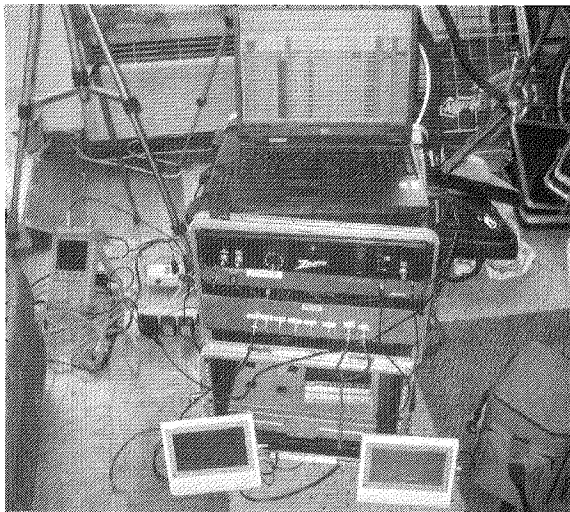
Figure 7a Indoor rack system

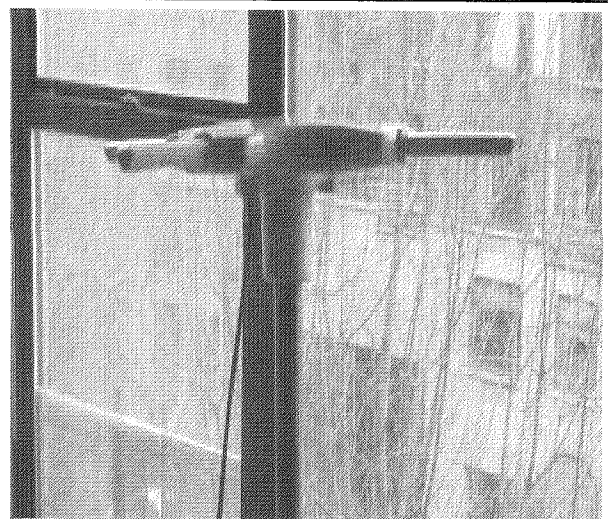
Figure 7b Smart Antenna

As part of the indoor DTV reception testing, a smart antenna was evaluated at *each* house, and for *each* receiver since this technology is expected to be available to consumers in the near future. The same smart antenna was used (sequentially) with each DTV receiver in order to minimize the number of test variables and thus keep the comparisons straightforward. The first step was to perform a channel scan with the receiver, letting it find as many DTV stations as it could, automatically optimizing the antenna for the best receive conditions. Once the scan was completed, which took noticeably *longer* than a normal scan without the smart antenna, and the received channels were stored in the receiver’s channel memory, the tester sequentially selected the three desired DTV test channels to evaluate reception.

The smart antenna was found to generally work when the manually adjusted antennas succeeded, and it generally did not work when the manually-adjusted antennas failed. With all the scenarios (three RF channels, two types of receive antennas, and DTx active and inactive), the smart antenna mimicked the manually-adjusted antenna in terms of DTV service almost 90% of the time. The other 10% of the time, the smart antenna split almost in half the number of times it was better than the manually-adjusted antenna and the times that it was worse.

While the smart antenna did *not* make much of an improvement, it essentially did not make matters worse, and it did provide *automatic* antenna adjustment (appreciated by most viewers, especially the “couch potatoes”), although at the cost of an increased channel scan time. It should be noted, however, that the smart antenna algorithms in these very early generation of smart controllers *apparently* do not constantly update the antenna optimization, nor is updating done when there is a channel change. Consequently, these primitive algorithms do not attempt to correct for quickly changing propagation effects (from dynamic conditions *outside* the home or movement of people *inside* the home) nor does it attempt to update its parameters for even slowly changing propagation effects (unless a manual scan is performed). Perhaps new algorithms may account for these types of changes in future products.

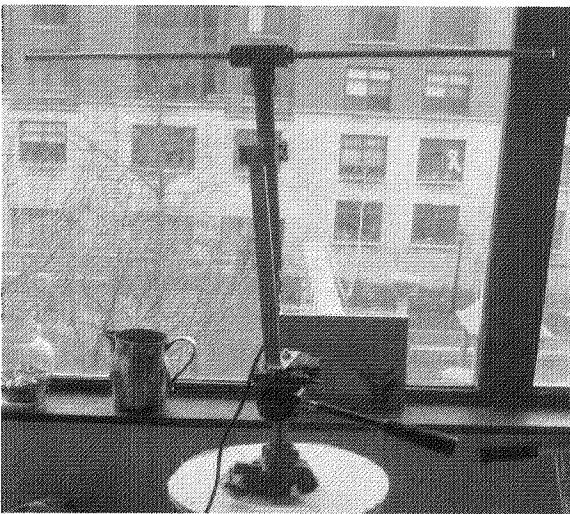
Figure 7c Calibrated VHF dipole antenna

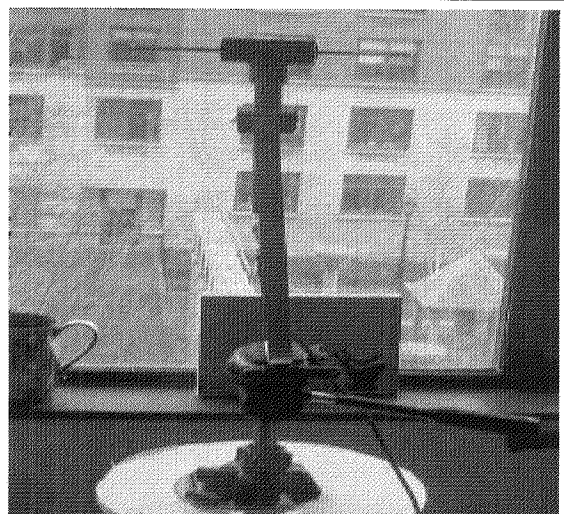
Figure 7d Calibrated UHF dipole antenna

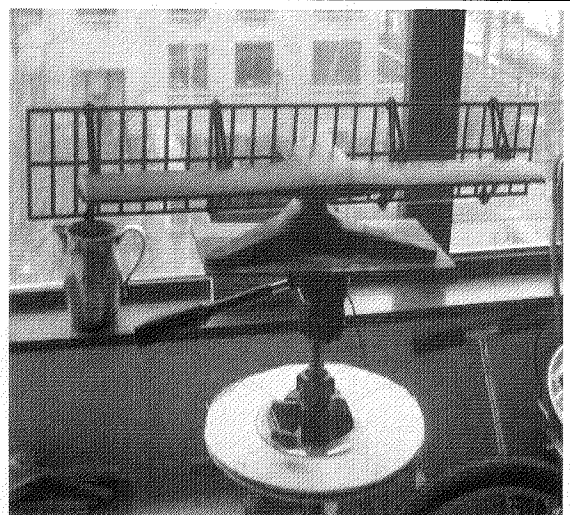
Figure 7e Sharpshooter VHF antenna

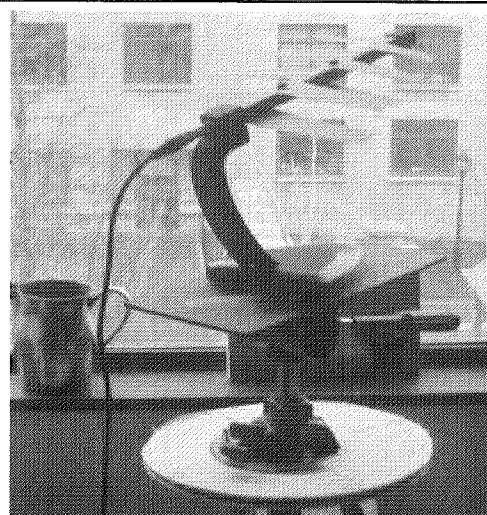
Figure 7f Silver Sensor UHF antenna

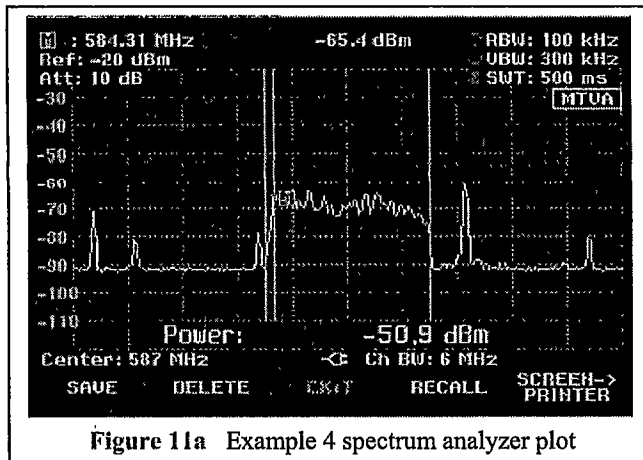
Figure 11a Example 4 spectrum analyzer plot

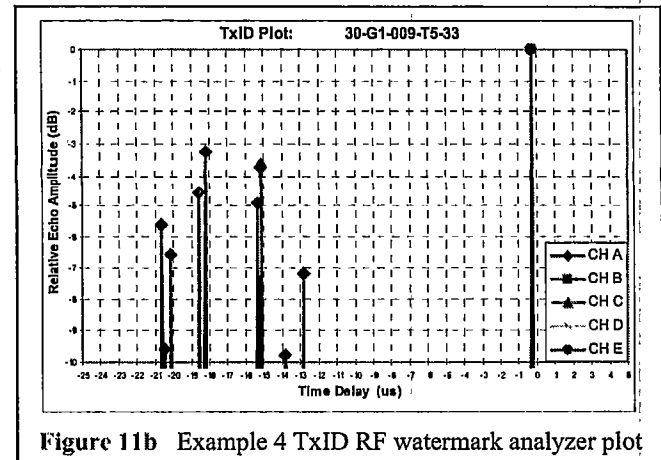
Figure 11b Example 4 TxID RF watermark analyzer plot

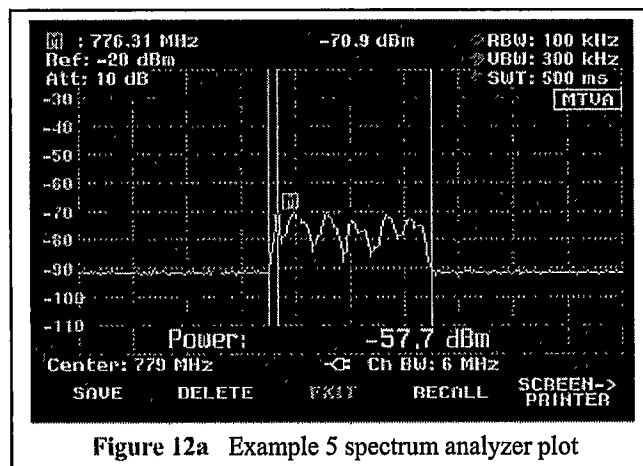
Figure 12a Example 5 spectrum analyzer plot

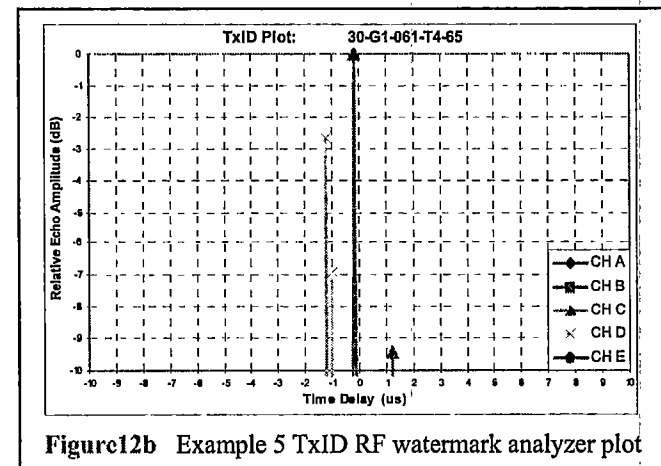
Figure 12b Example 5 TxID RF watermark analyzer plot

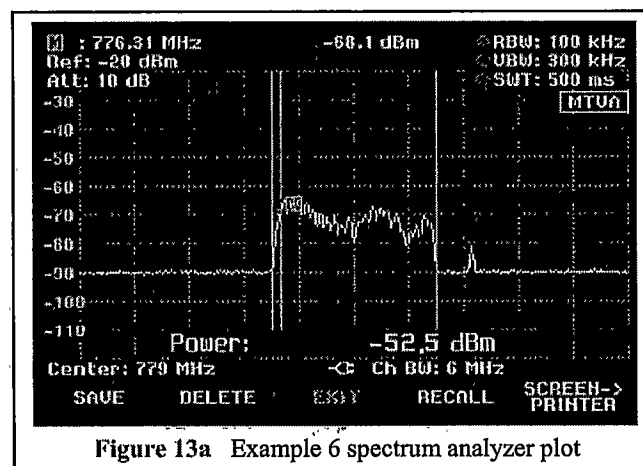
Figure 13a Example 6 spectrum analyzer plot

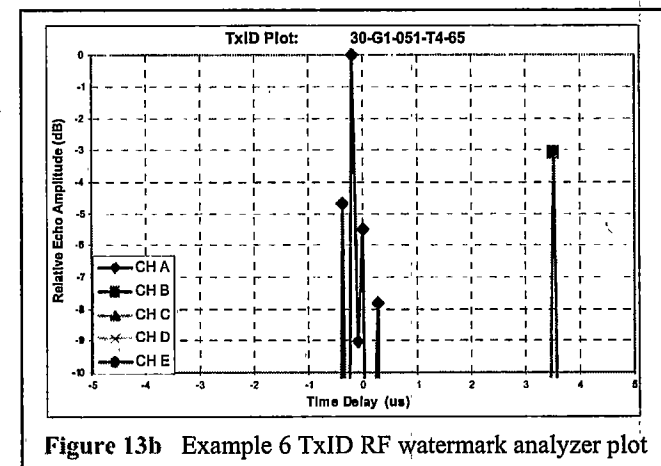
Figure 13b Example 6 TxID RF watermark analyzer plot
